RE: FINAL ROADWAY MATERIALS REPORT (Materials Phases I(R)-II-III)

Roadway Materials Report

State, FY19 D4 Materials Reconnaissance

(SH-75, River St to Clubhouse Dr)

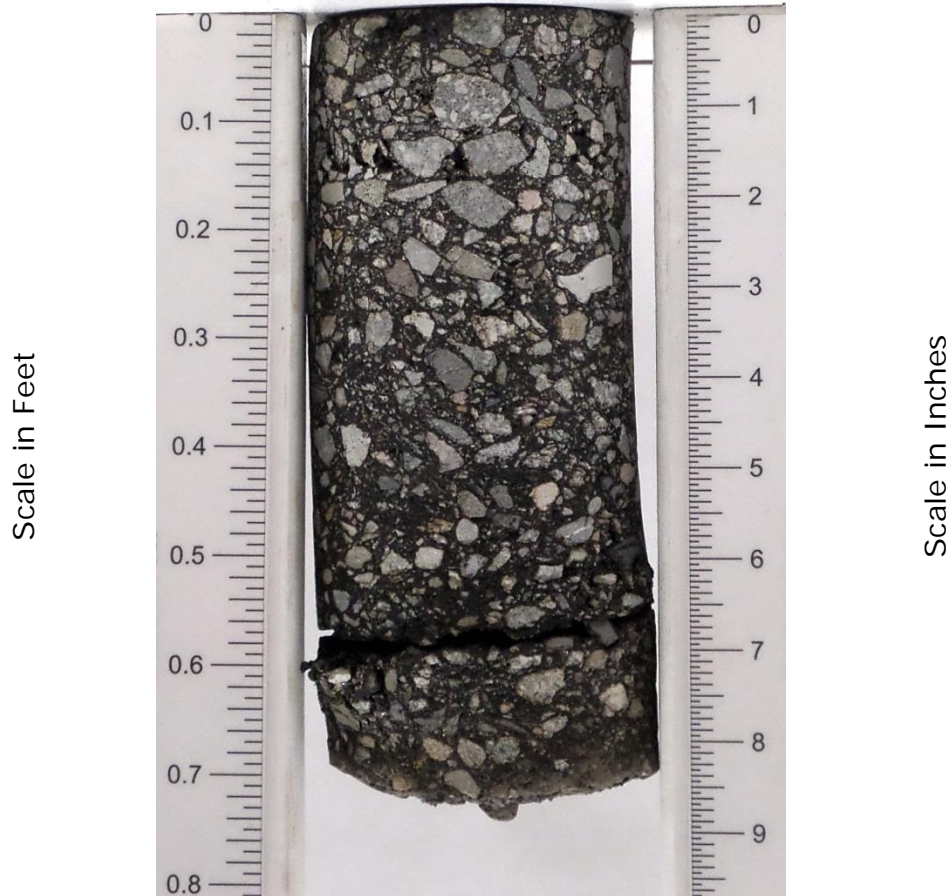
Photo 1: AG-01; CR-01; 0.0'- 0.72'.

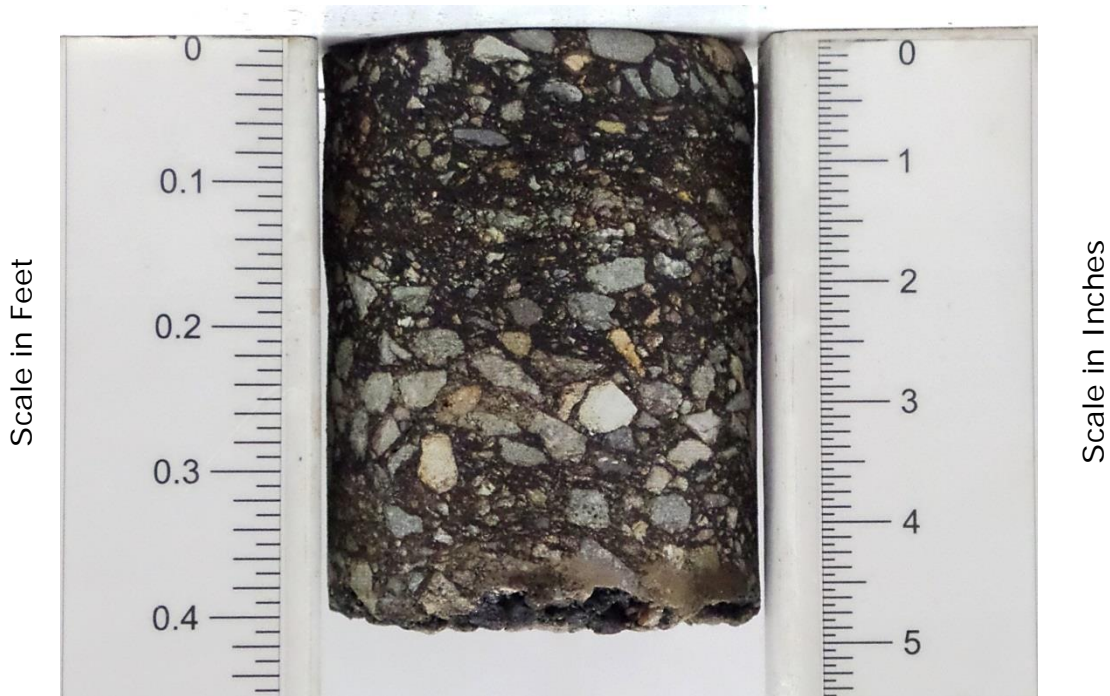
Photo 4: AG-04; CR-19; 0.0'- 0.42'.

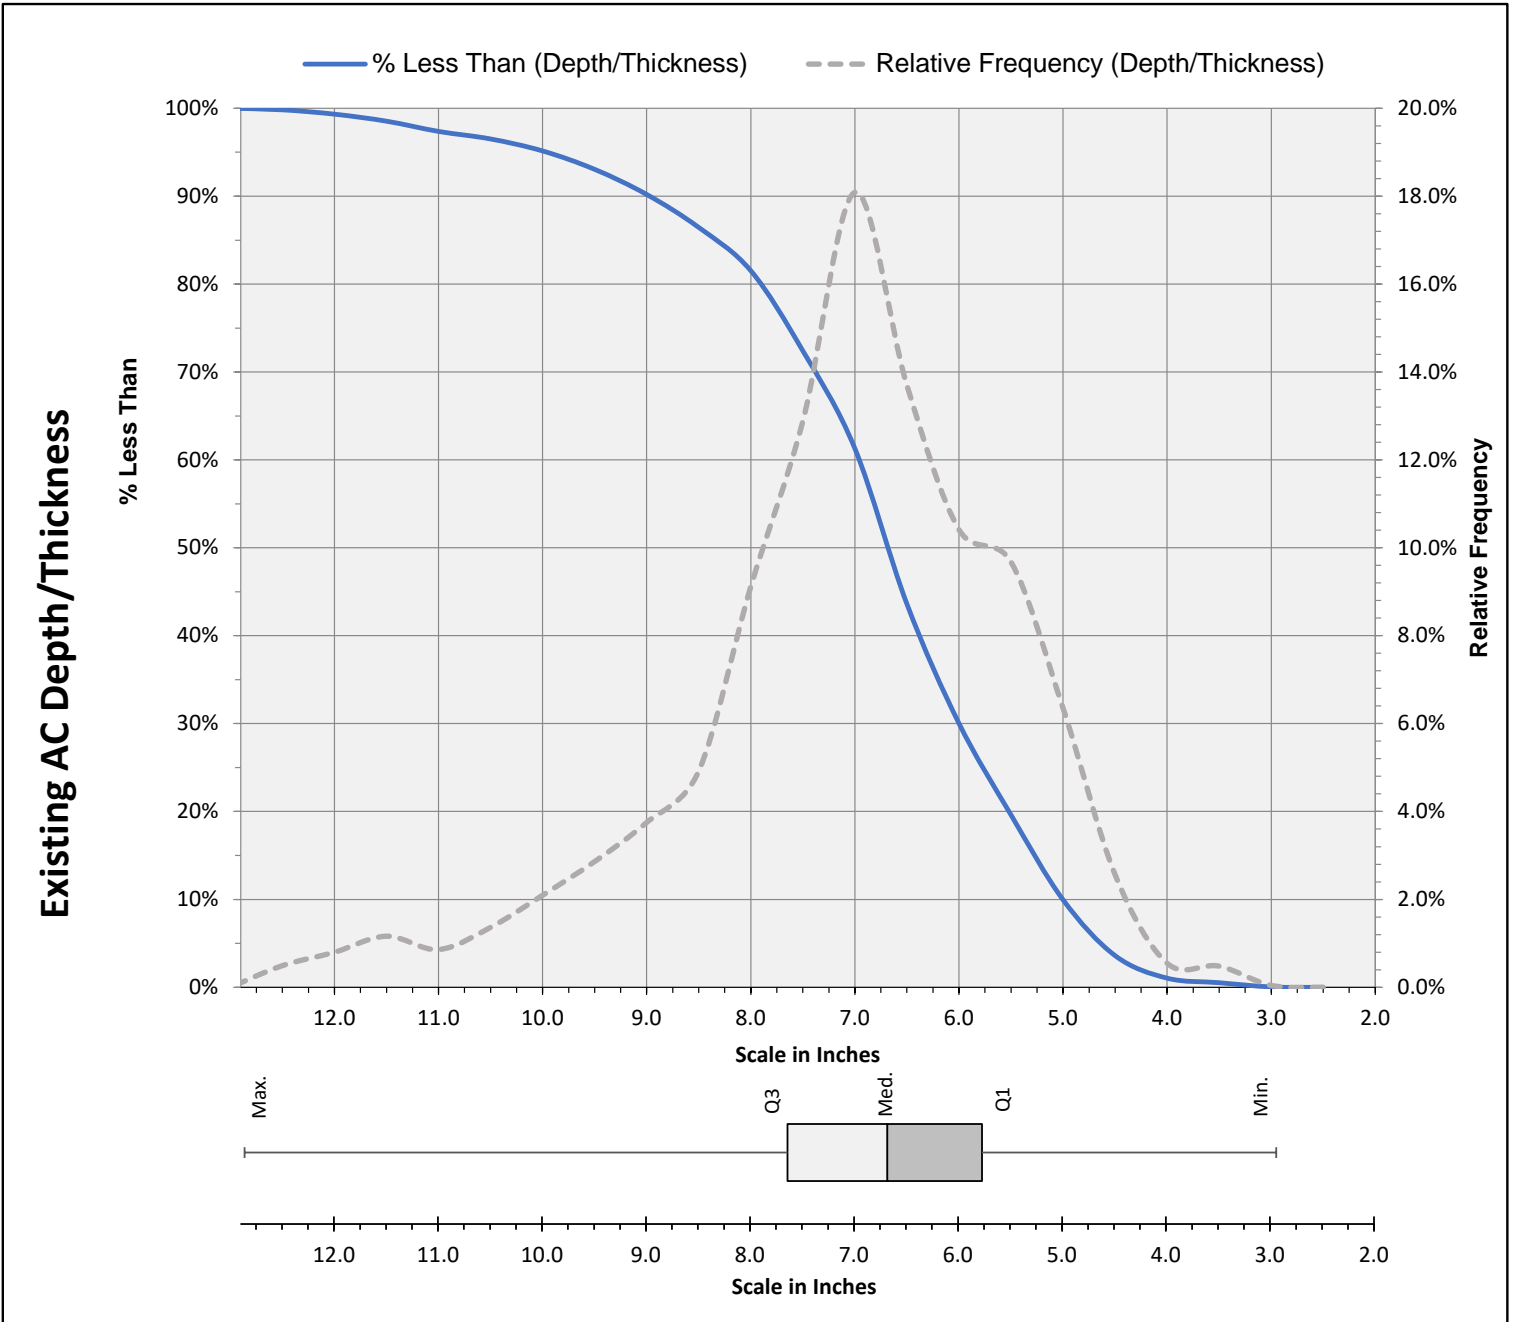
(South Bound, Lane 0, Right Wheel Path)

Existing AC Depth/Thickness Statistics

Average= 6.9 in. (0.57 ft.)
 Max= 12.9 in. (1.07 ft.)
 Min= 2.9 in. (0.25 ft.)
 SD= 1.6 in. (0.13 ft.)
 Median= 6.7 in. (0.56 ft.)
 Q1= 5.8 in. (0.48 ft.)
 Q3= 7.6 in. (0.64 ft.)

Recommended Full-Depth AC Removal and Replacement (River St to Saddle Rd) Design (20-Year Analysis)	
Pavement Design Element	Thickness (feet)
Remove Existing AC (Average)	0.57
HMA (PG 70-34)	0.50
¾" Untreated Aggregate Base, Type "B" (leveling course)	0.07 ⁽¹⁾
Average Undisturbed Existing Base/Subbase	0.71
Estimated Rise in Existing Roadway Profile	0.00
¹ 0.07 is the average leveling course thickness. The leveling course thickness may range from 0.00 feet to 0.50 feet thick.

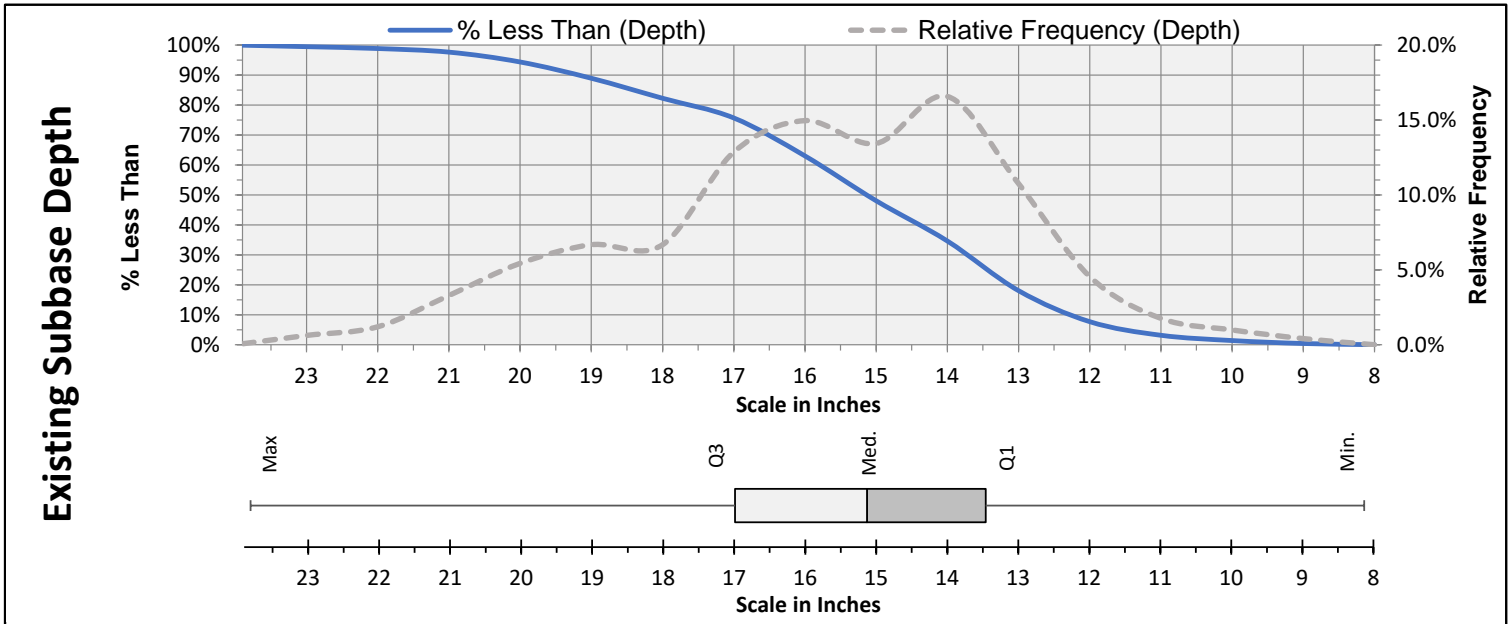
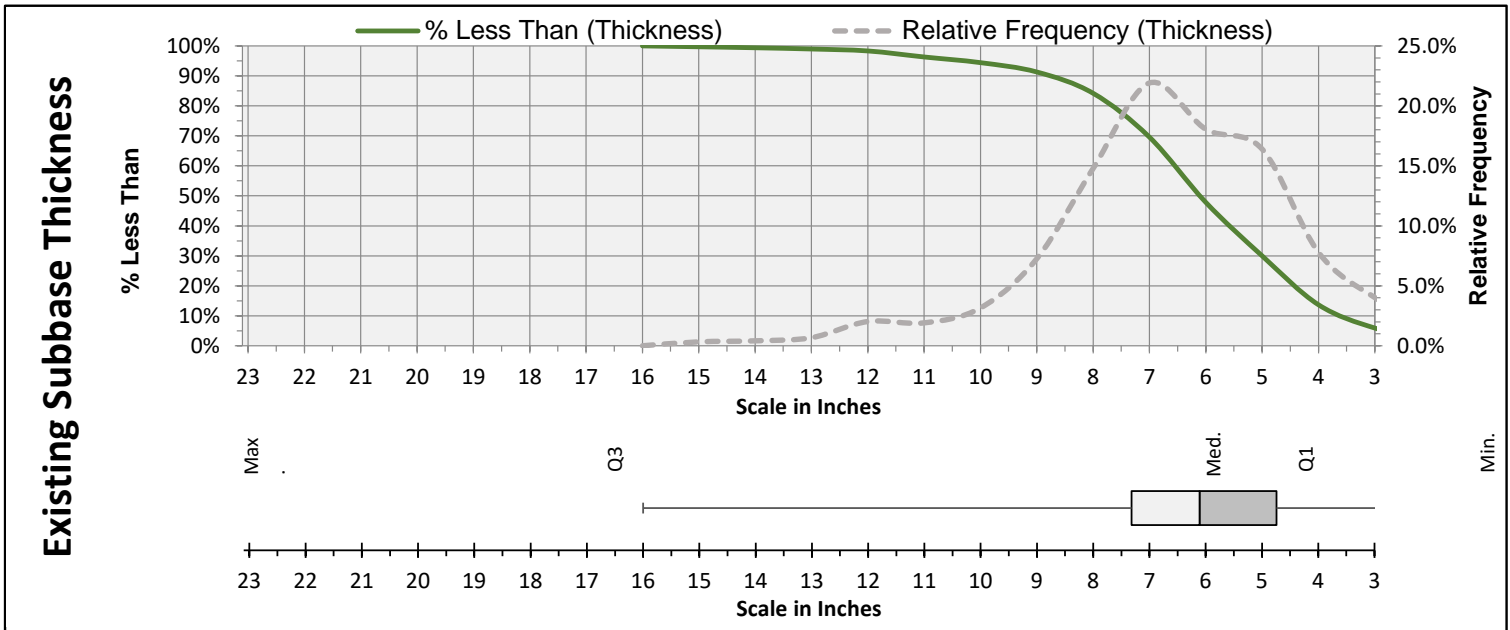
(South Bound, Lane 0, Right Wheel Path)

Existing Subbase Depth Statistics

Average= 15.4 in. (1.28 ft.)
 Max= 23.8 in. (1.98 ft.)
 Min= 8.1 in. (0.68 ft.)
 SD= 2.7 in. (0.22 ft.)
 Median= 15.1 in. (1.26 ft.)
 Q1= 13.5 in. (1.12 ft.)
 Q3= 17 in. (1.42 ft.)

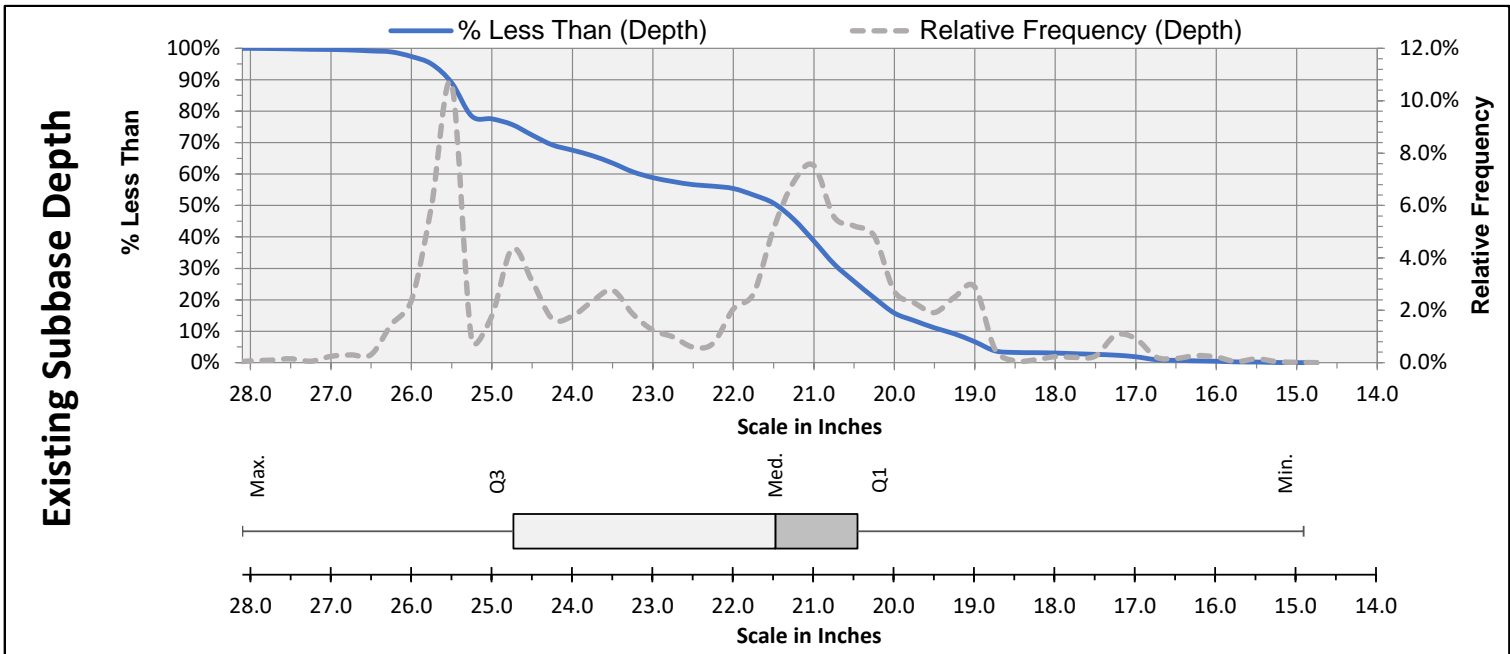
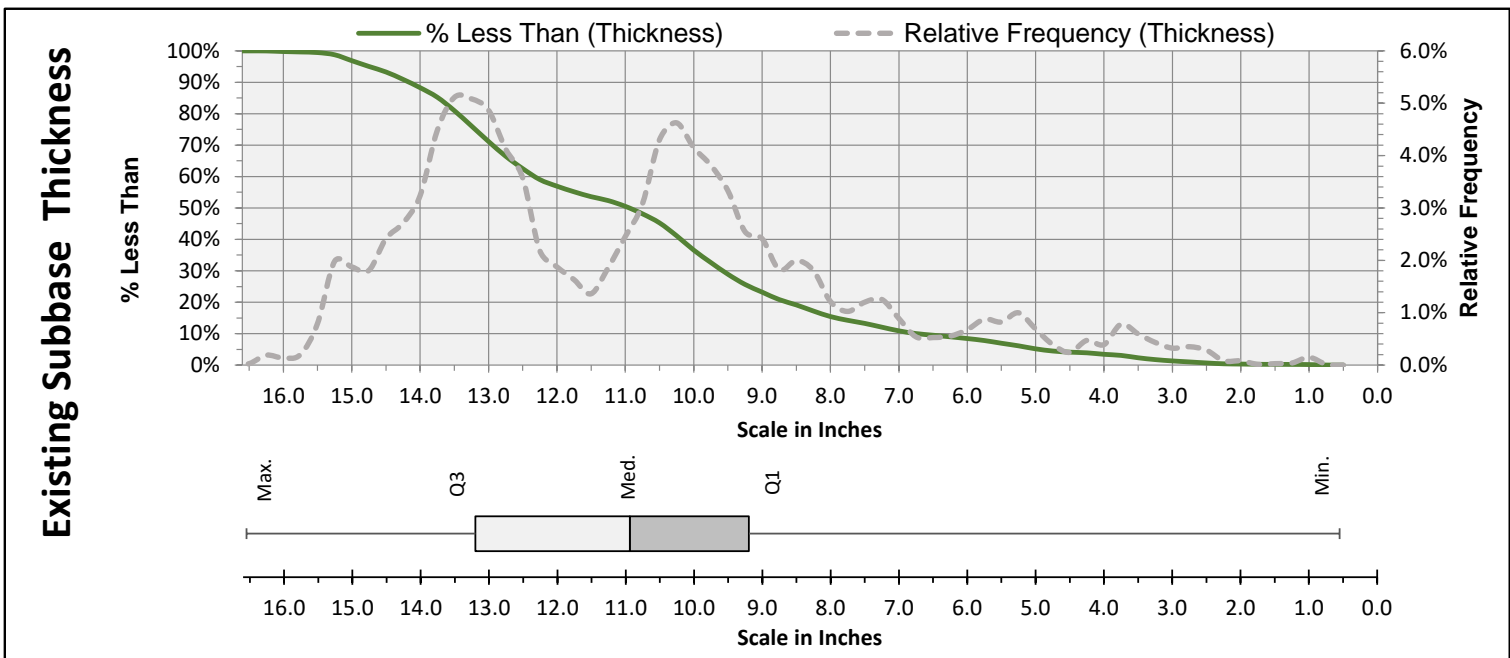
(South Bound, Lane 0, Right Wheel Path)

Existing Subbase Depth Statistics

Average= 22.3 in. (1.86 ft.)
 Max= 28.1 in. (2.34 ft.)
 Min= 14.9 in. (1.24 ft.)
 SD= 2.5 in. (0.21 ft.)
 Median= 21.5 in. (1.79 ft.)
 Q1= 20.5 in. (1.7 ft.)
 Q3= 24.7 in. (2.06 ft.)
